### Astonishingly fast MDS remote response using System 1 20.1 in Argentina

**Industry:** Pulp and Paper

**Application:** In house Power Generation

**Solution:** Remote Diagnostic Services - System 1 20.1

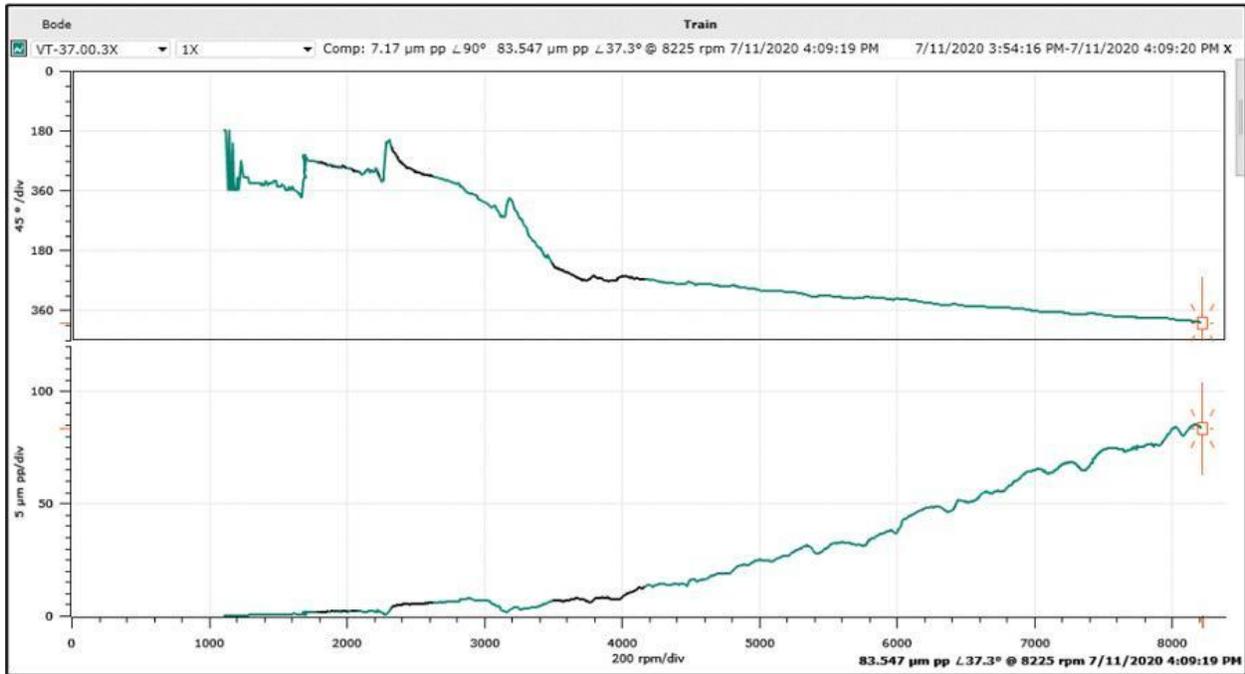
Plot # 1 shows a rapid increase in synchronous amplitudes above 5000 rpm on the turbine non-drive end bearing. Along with the increase in amplitude, direct orbits at both bearings presented a clearly circular shape, as shown on Plot # 2. Also, as indicated in Plot # 2, the phase reference or keyphasor dots at both orbits were located opposite each other, indicating second mode vibration.

Plot #1 – Bode diagram showing rapid amplitude increase above 5000 rpm, turbine non-drive end bearing.

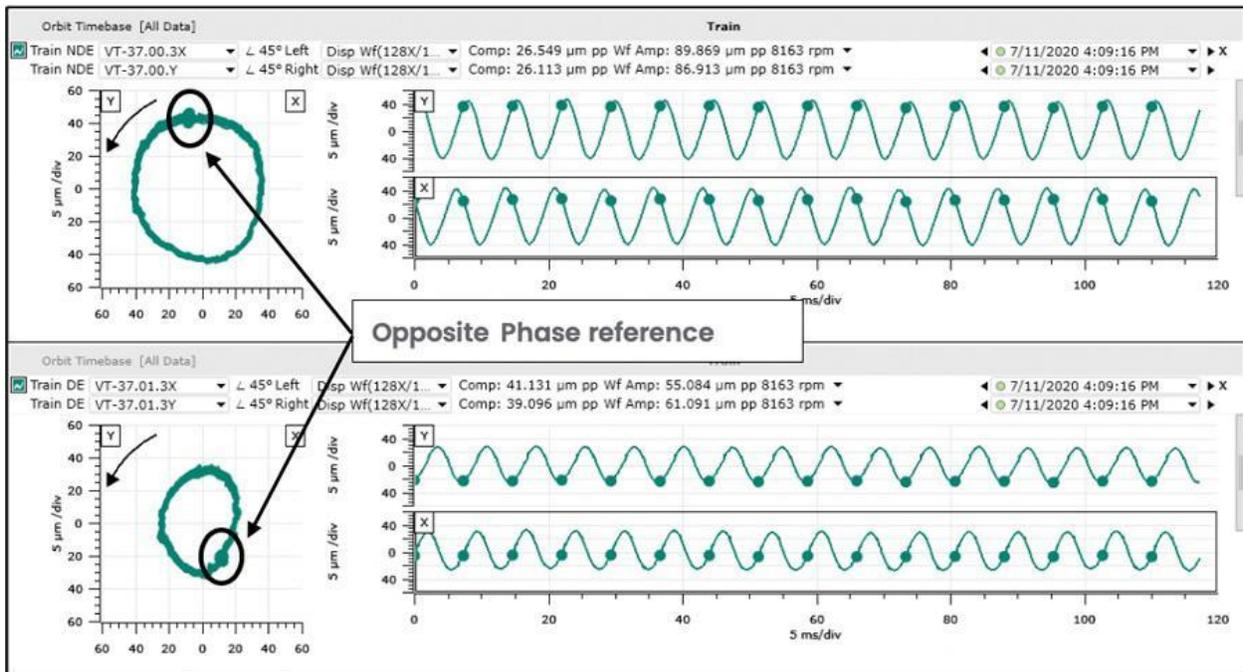
Plot #2 – Compensated direct orbits for turbine non-drive end (top) and drive end (bottom) bearings, recorded at 8163 rpm just before the trip.

Even though this behavior seemed to indicate elevated residual unbalance on the second mode, the conditions in which these symptoms manifested made it impossible for the rotor to develop such an unbalance condition while operating in turning gear (vibration amplitudes had been significantly lower before the trip event). Additionally, a bow due to lack of turning gear would have caused high “in phase” vibration for the first mode, which was not observed.

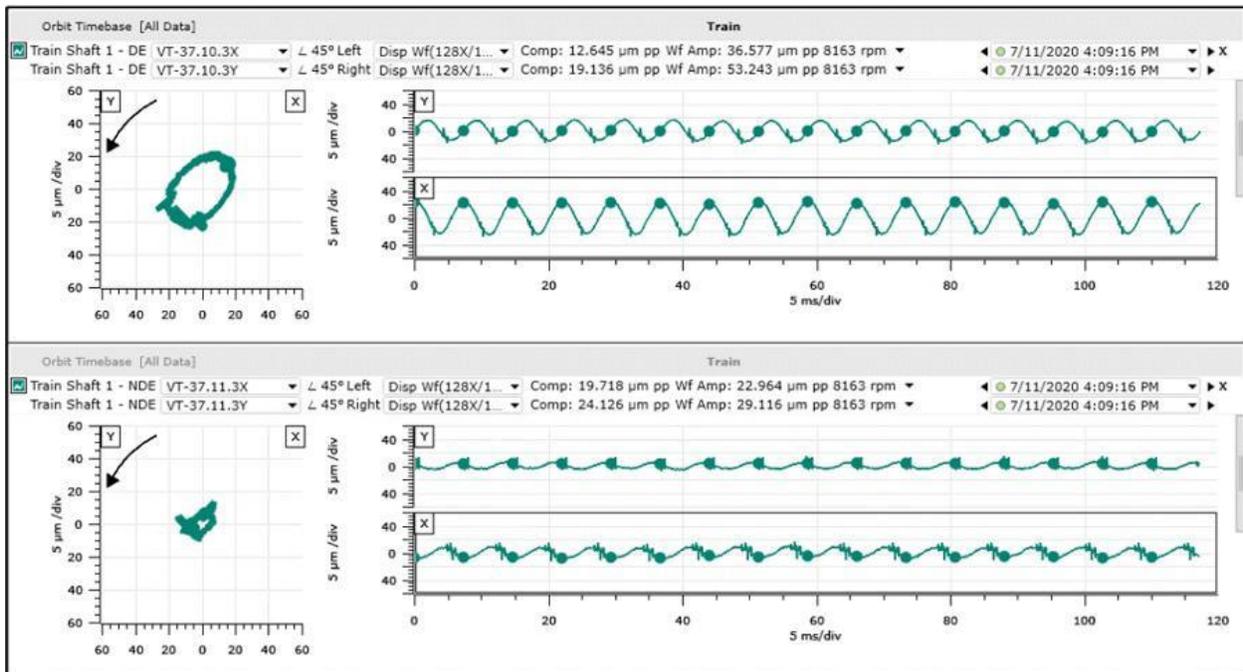
Given the relatively high synchronous amplitudes recorded also at the pinion drive end bearing (see plot # 3), the coupling between turbine and gearbox was believed to be related to the observed behavior.

Plot #3 – Compensated direct orbits for pinion drive end (top) and non-drive end (bottom) bearings, recorded at 8163 rpm just before the trip.

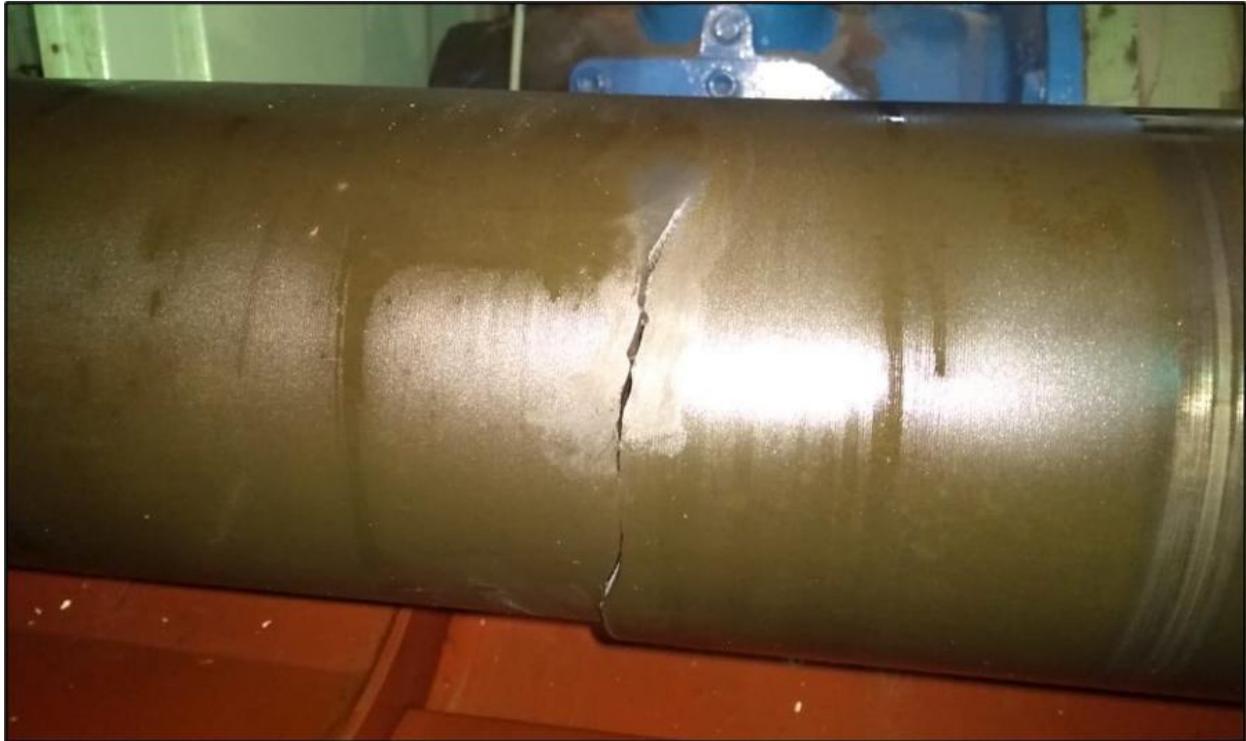
That same day after the new trip, the coupling guard was removed, exposing a significant circumferential crack in the spool piece, shown in picture # 1. A preliminary analysis of the failure indicated that, during the two hours with no turning gear operation, the casing contraction during cooldown had applied excessive radial load on the coupling, intensive enough to initiate the crack or enable the propagation of an existing smaller one. The crack had induced a bow in this coupling component, which had affected the turbine rotor second mode response at speeds above 5000 rpm.

Picture #1 – Crack in the middle section of the coupling spool piece.

The damaged spool piece was replaced, and the unit was ready to start up on Sunday July 12nd at noon. Plot # 4 shows a smooth synchronous response in the whole speed range, with amplitudes below 25  $\mu\text{m}$  pp (1 mil pp). Plot # 5 shows the compensated direct orbits for both turbine bearings once the unit reached full speed (8500 rpm). Once at full speed, load was gradually increased reaching normal demand by Monday 13th.

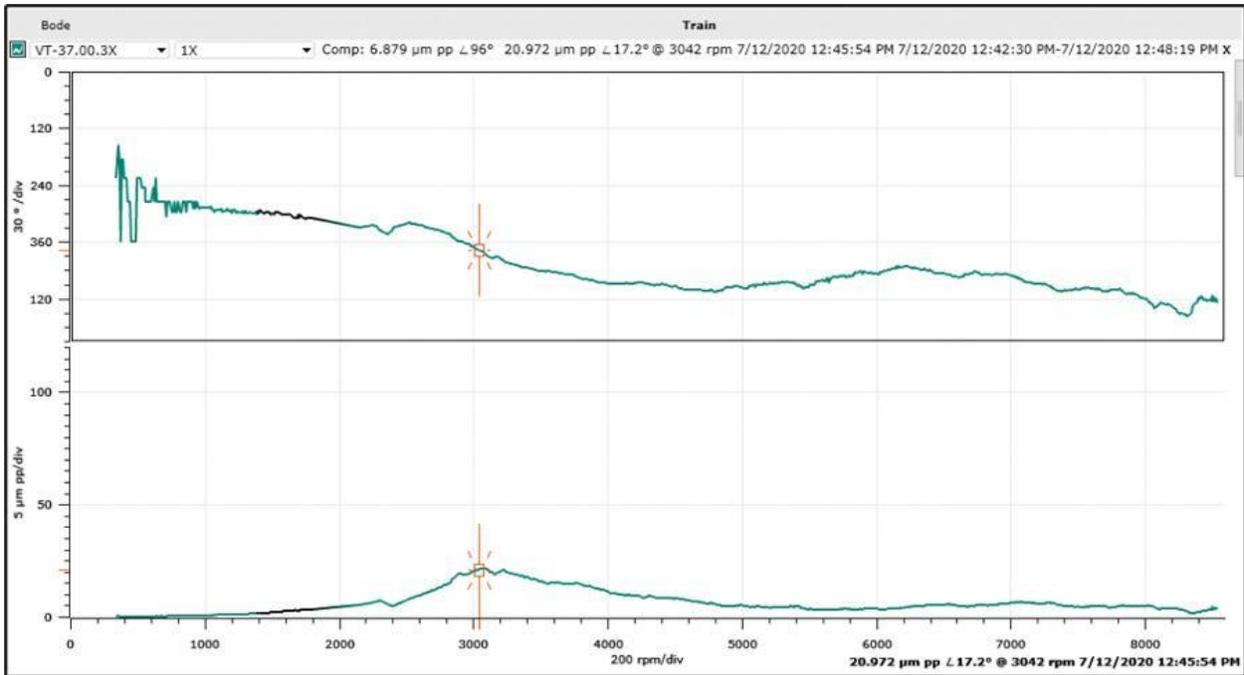
Plot #4 – Bode diagram showing a smooth synchronous response during start up, after coupling pool replacement.

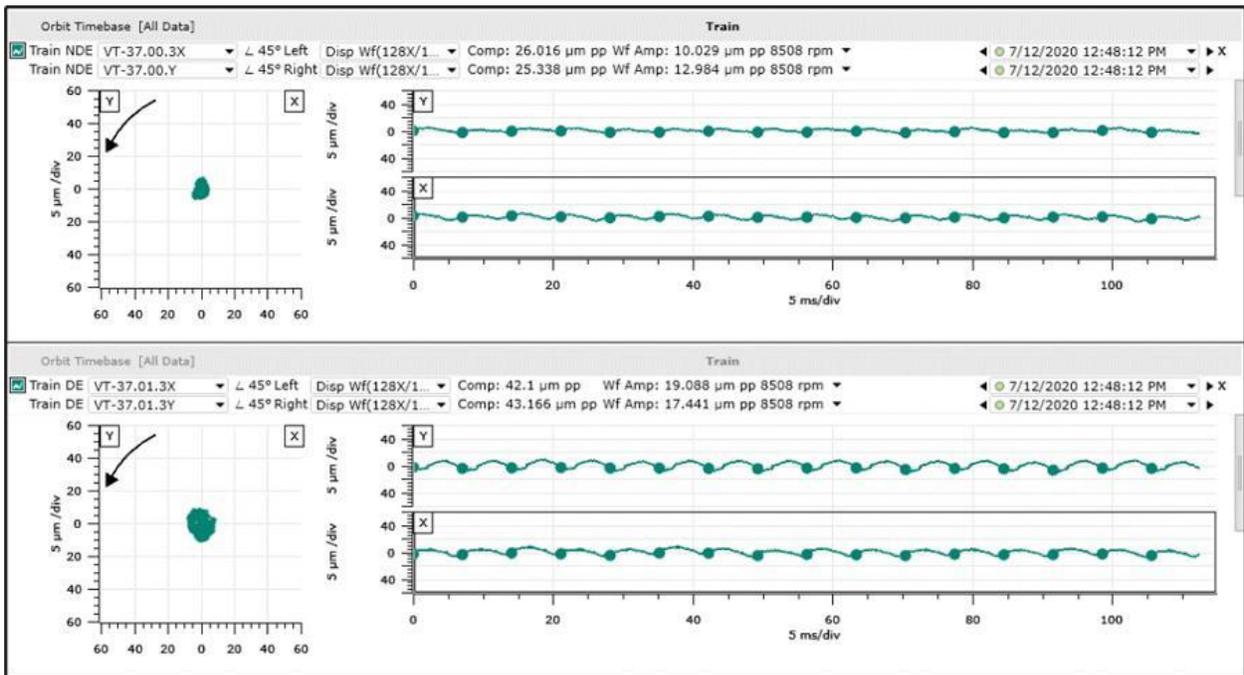
Plot #5 – Compensated direct orbits for turbine non-drive end (top) and drive end (bottom) bearings, recorded at full speed (8500 rpm), after coupling pool replacement.
